# Dam Safety and Risk Management in Taiwan

Sinotech Engineering Consultants

### Case Study: Xinshan Dam

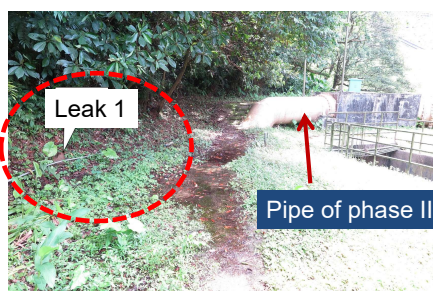
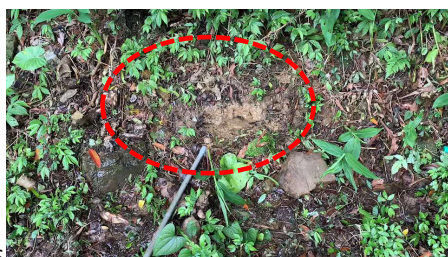
## Abnormal Leak Observed

- 🌐 In June 2022, two leaks were observed at the weak points of Phase 1 intake tunnels/pipes.
- 🌐 Based on the results of the PFMA, these leaks may indicate that pipe failure is occurring, which could eventually lead to uncontrolled but limited reservoir discharge. However, they do not pose a risk of dam failure.
- 🌐 Subsequently, an investigation was conducted to identify the source of these leaks.

- ➔ Observing seepage quantity
- ➔ Installing cameras to monitor on-site changes

- ➔ Conducting water quality analysis, including pH value, temperature, and conductivity, etc..
- ➔ Performing tracer tests using food-grade dye.

- ➔ Assessing the time required to empty the reservoir (40 days).
- ➔ Estimating the time needed to refill the reservoir to its full capacity (120 days).
- ➔ Determining when to start draining out the reservoir (Sep. 1~Dec. 31)
- ➔ Studying repair methods.

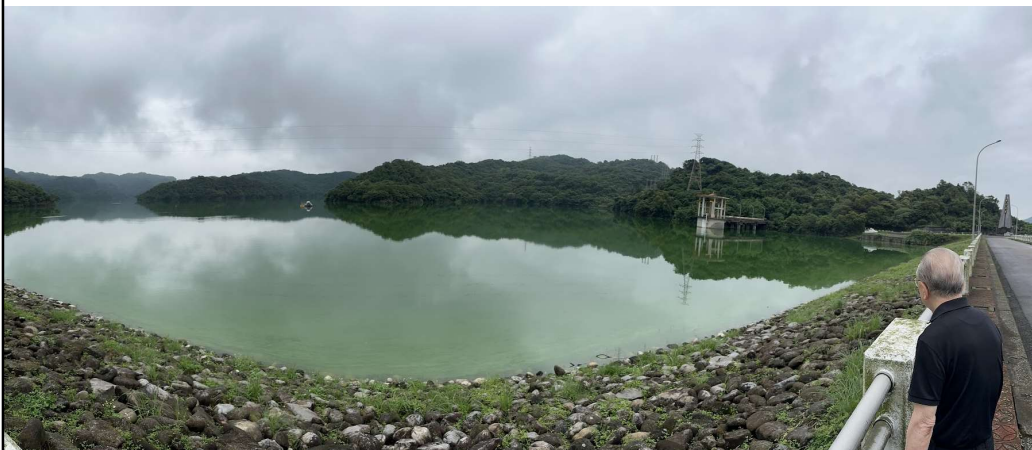
## Recharge of the Reservoir

- 🌐 All the restoration works were completed within 3 weeks. **(End of Feb)**
- 🌐 The reservoir filled to its full capacity in June 2023 and did not cause any impact on the water supply.
