World Water Congress  
25-29 May, 2015; Edinburgh, Scotland

# Microbiological contamination of pond water and associated drinking water risk in rural coastal areas of Bangladesh

Author : Raju Sarkar, Zahid Hayat Mahmud, Rezaul Karim, Joachim Vogt

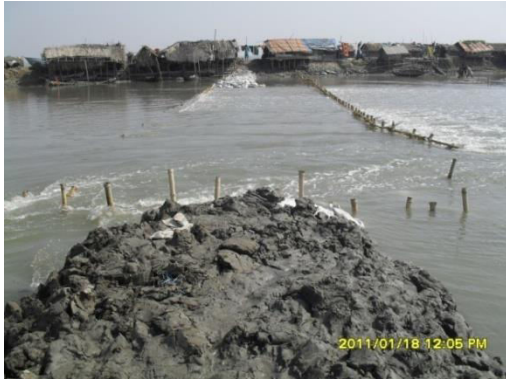
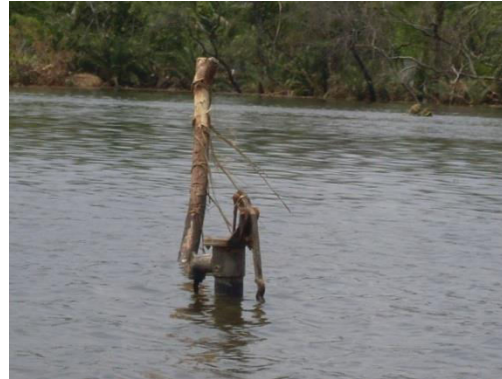
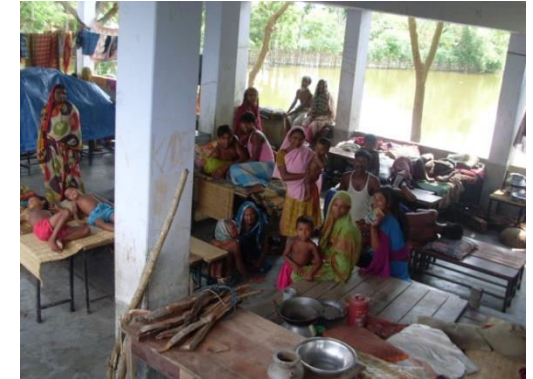
## Damaged embankment, Contaminated sources and Refuge in cyclone shelters

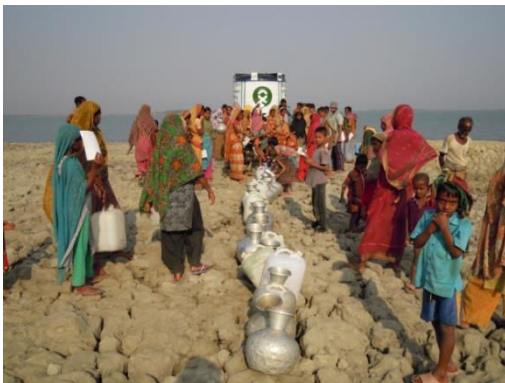
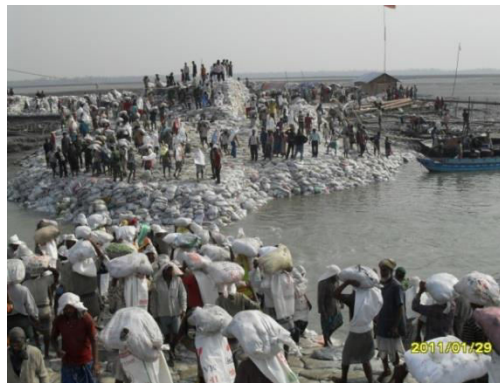
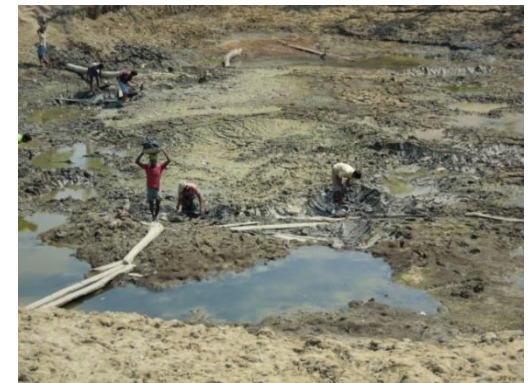
## Water relief, Embankment reconstruction, Restoration of contaminated sources

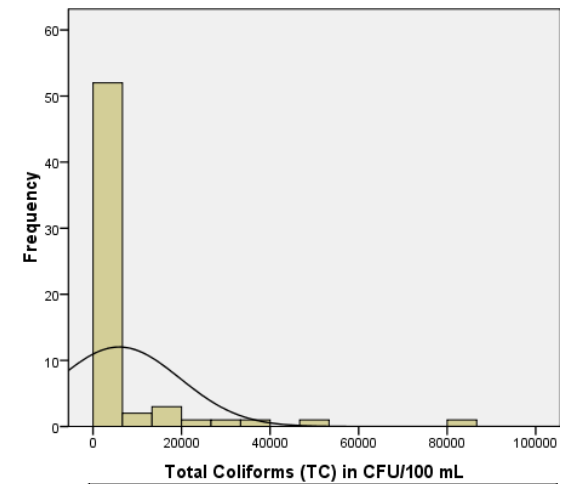
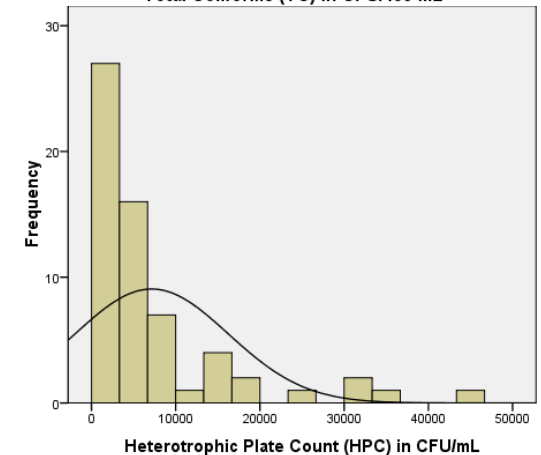
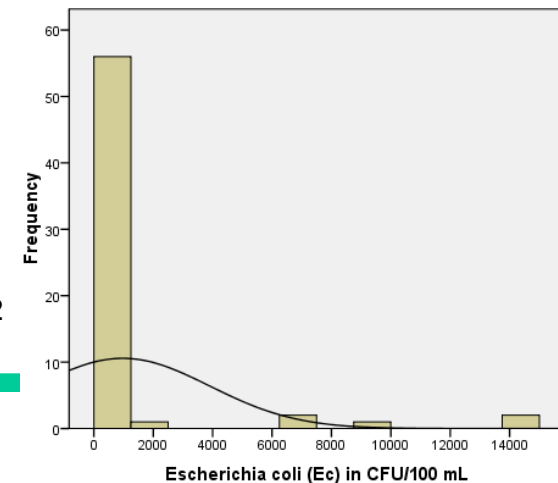
1. The recorded maximum concentration of

- TC HPC, and Ec in the source-samples is 8300 CFU/100ml, 45000 CFU/ml and 14000 CFU/100ml respectively.
- The WHO standard for these three parameters is 0, less than 500 CFU/ml and 0 in that order.

2. The point of use (household samples) concentrations are comparatively lower in the cases of alum [ $KAl(SO_4)_2 \cdot 12H_2O$ ] use

3. Presence of *Vibrio cholera* has been identified in about 42% samples.

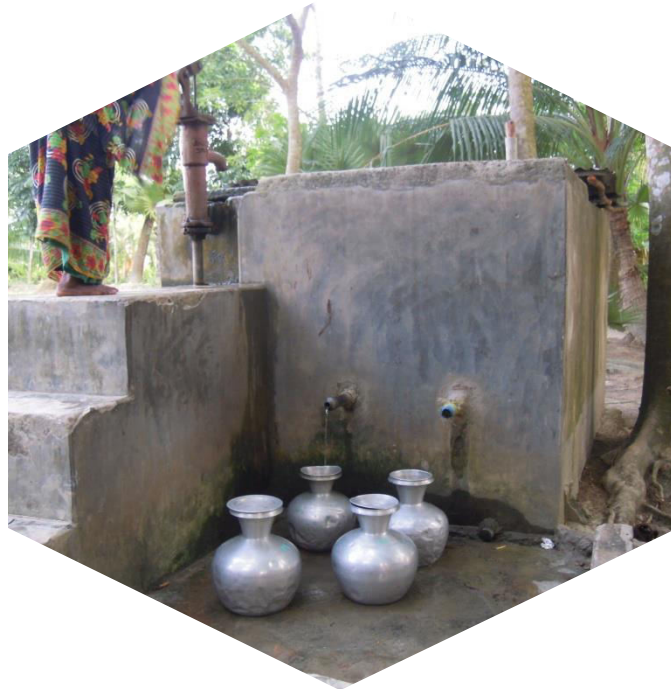
**F1:** Presence and functionality of a PSF installed beside the pond

**F6:** Contamination by previous cyclone surge

**F5:** Height of the pond bank from the adjacent land

**F2:** Presence of toilet within 10 m buffer

**F3:** Multipurpose use of the pond specially for bathing and cleaning

**F4:** The use of alum [ $\text{KAl}(\text{SO}_4)_2 \cdot 12\text{H}_2\text{O}$ ] for water purification at households

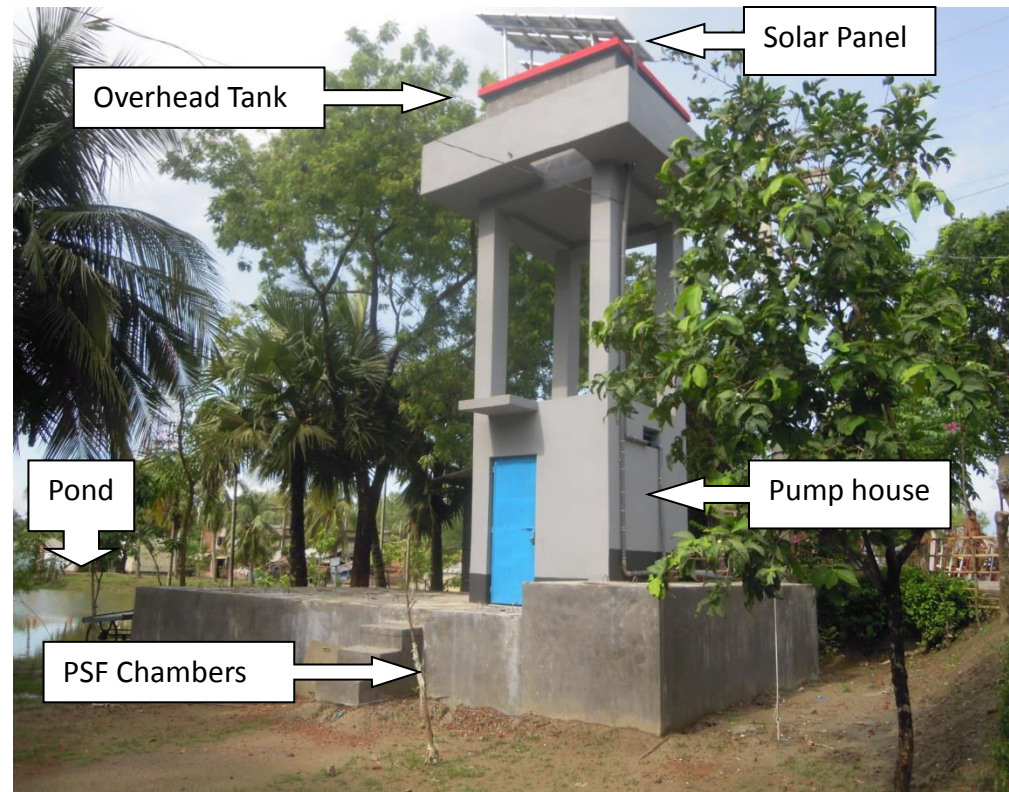
→ Experimentally established by GIZ in SW-Coastal Bangladesh

→ Water flow direction:  
Pond ► PSF ► Overhead Tank ► Supply Point

→ 5 chambered PSF. 3 filled with sand, brick chips, alum and coal chips

→ Solar energy runs the pump to let water in PSF and to pump the treated water in overhead tank
