Restoring Water Resources Through Soil Remediation: A Case Study on Smouldering Remediation

Dr Christine Switzer

Department of Civil and Environmental Engineering

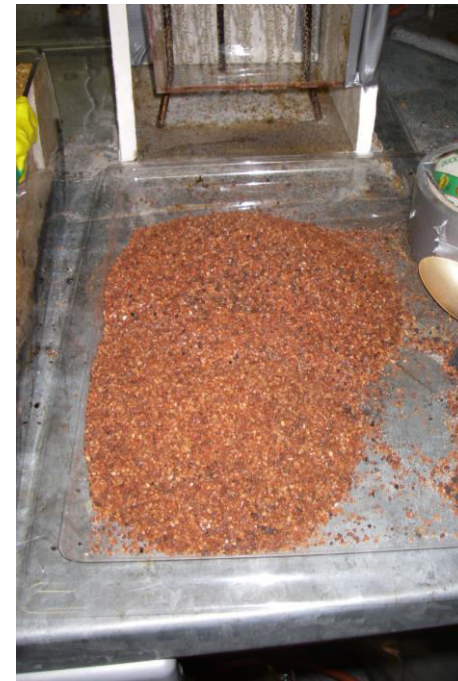
Laboratory Experiments: Chemical Analysis

Coarse Sand

Sand + Fresh Coal Tar

70,000mg/kg

Inside Combustion Zone

<0.1mg/kg

Outside Combustion Zone

up to
1000mg/kg

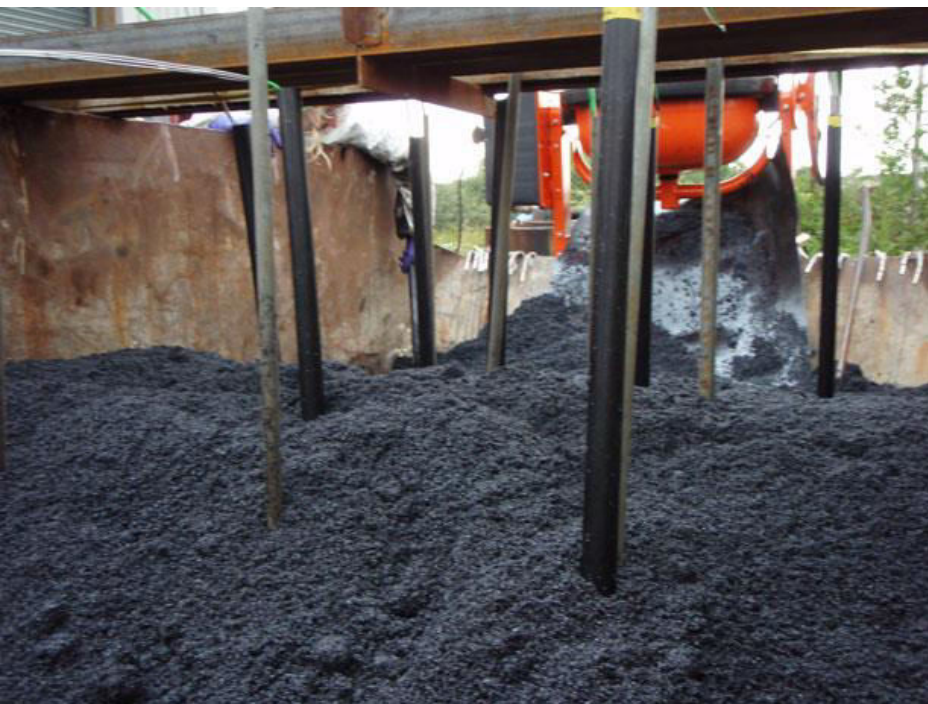
Smouldering Remediation Ex Situ Demonstration

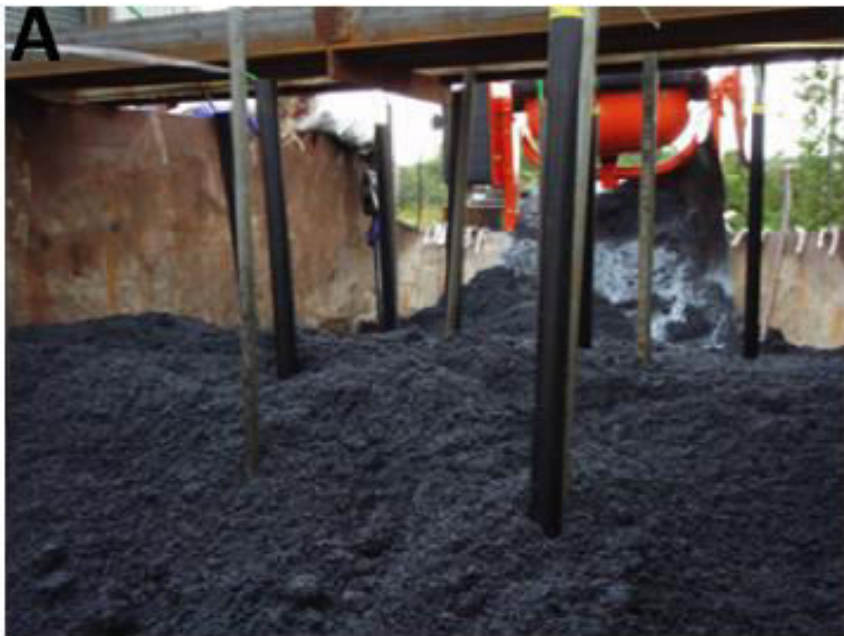
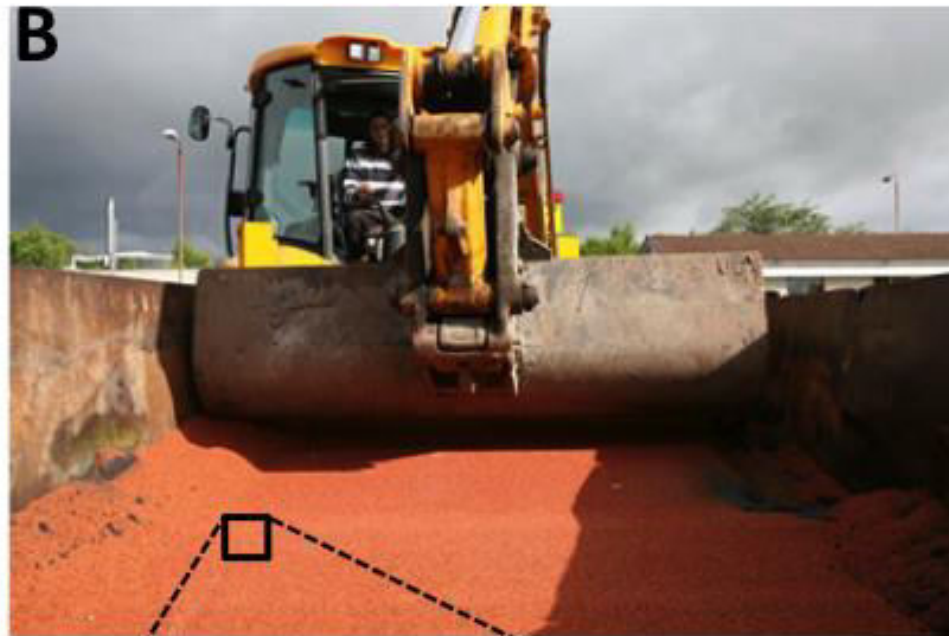
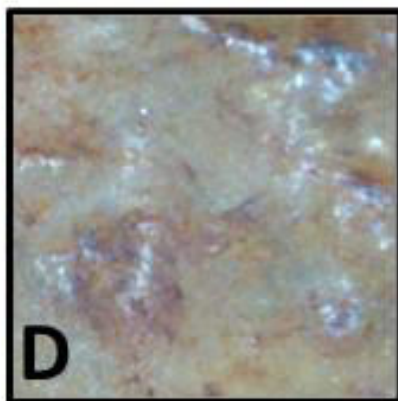
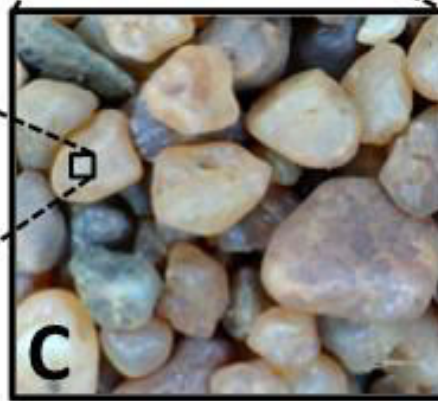
Conc (TPH) = 31,000 mg/kg \pm 14,000 mg/kg

Conc (TPH) = 10 mg/kg \pm 4 mg/kg

Treatment	Analysis		Quartz	Tridymite	Cristobalite	Dumortierite	Geothite	Hematite
	Grains	points						
untreated	5	9	1	0	0	0	0	0
500°C	3	5	0.60	0	0	0	0.40	0
1000°C	3	9	0.56	0.22	0	0	0	0.22
smouldering remediation	12	37	0.32	0.16	0.08	0.22	0.14	0.05

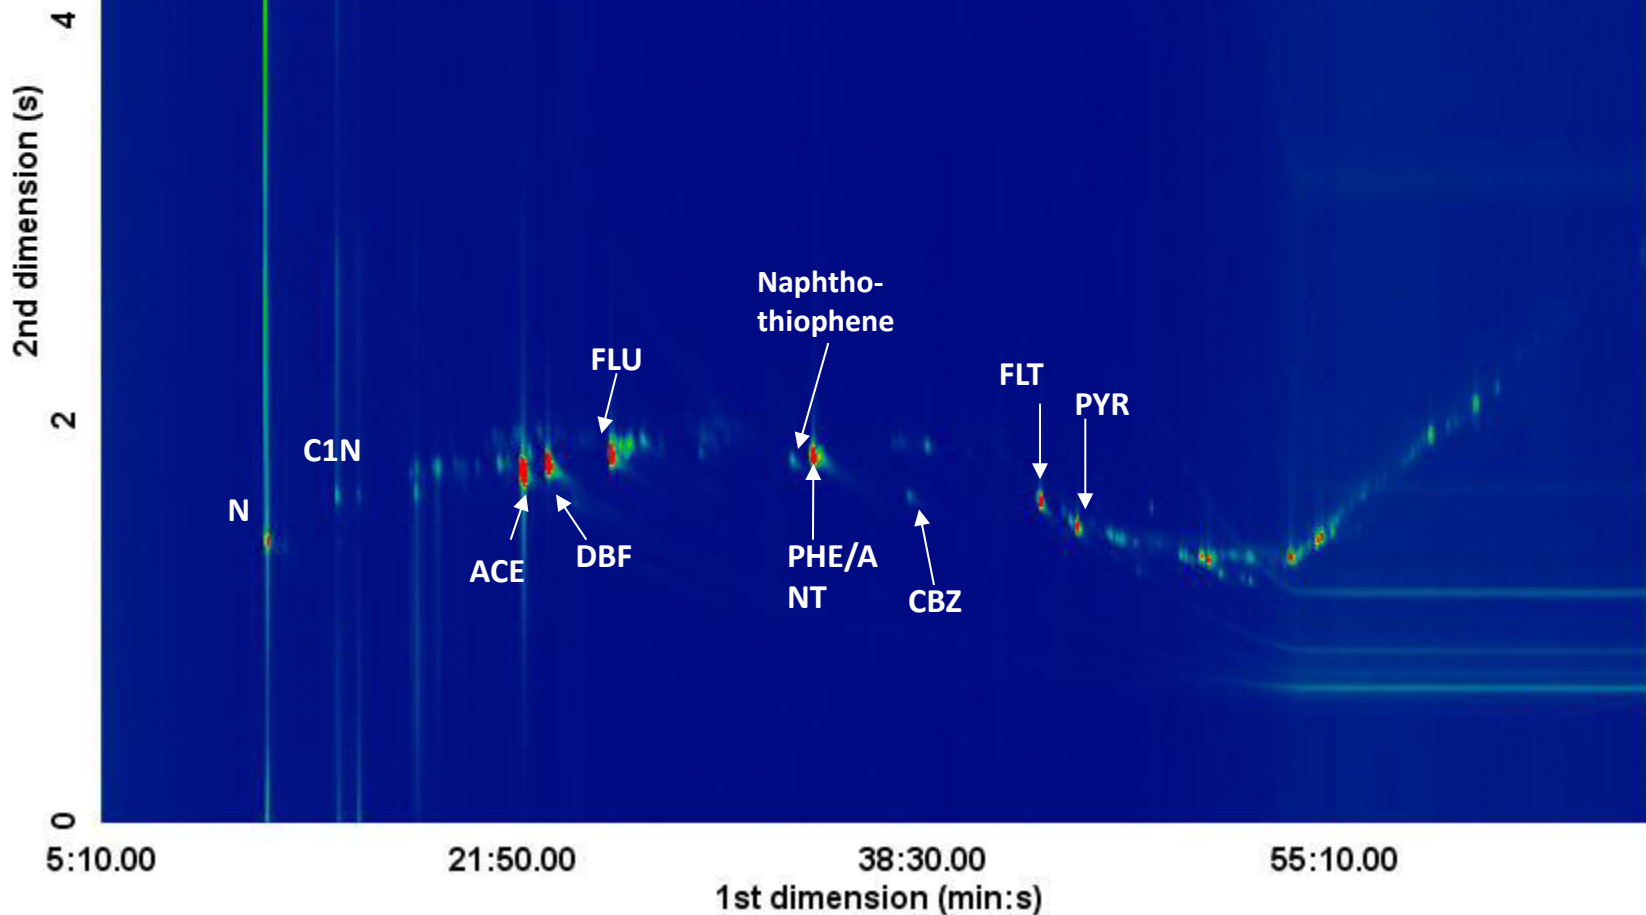
Coal tar

Fate of Organic Contaminants: GCxGC-TOFMS

Masses: TIC

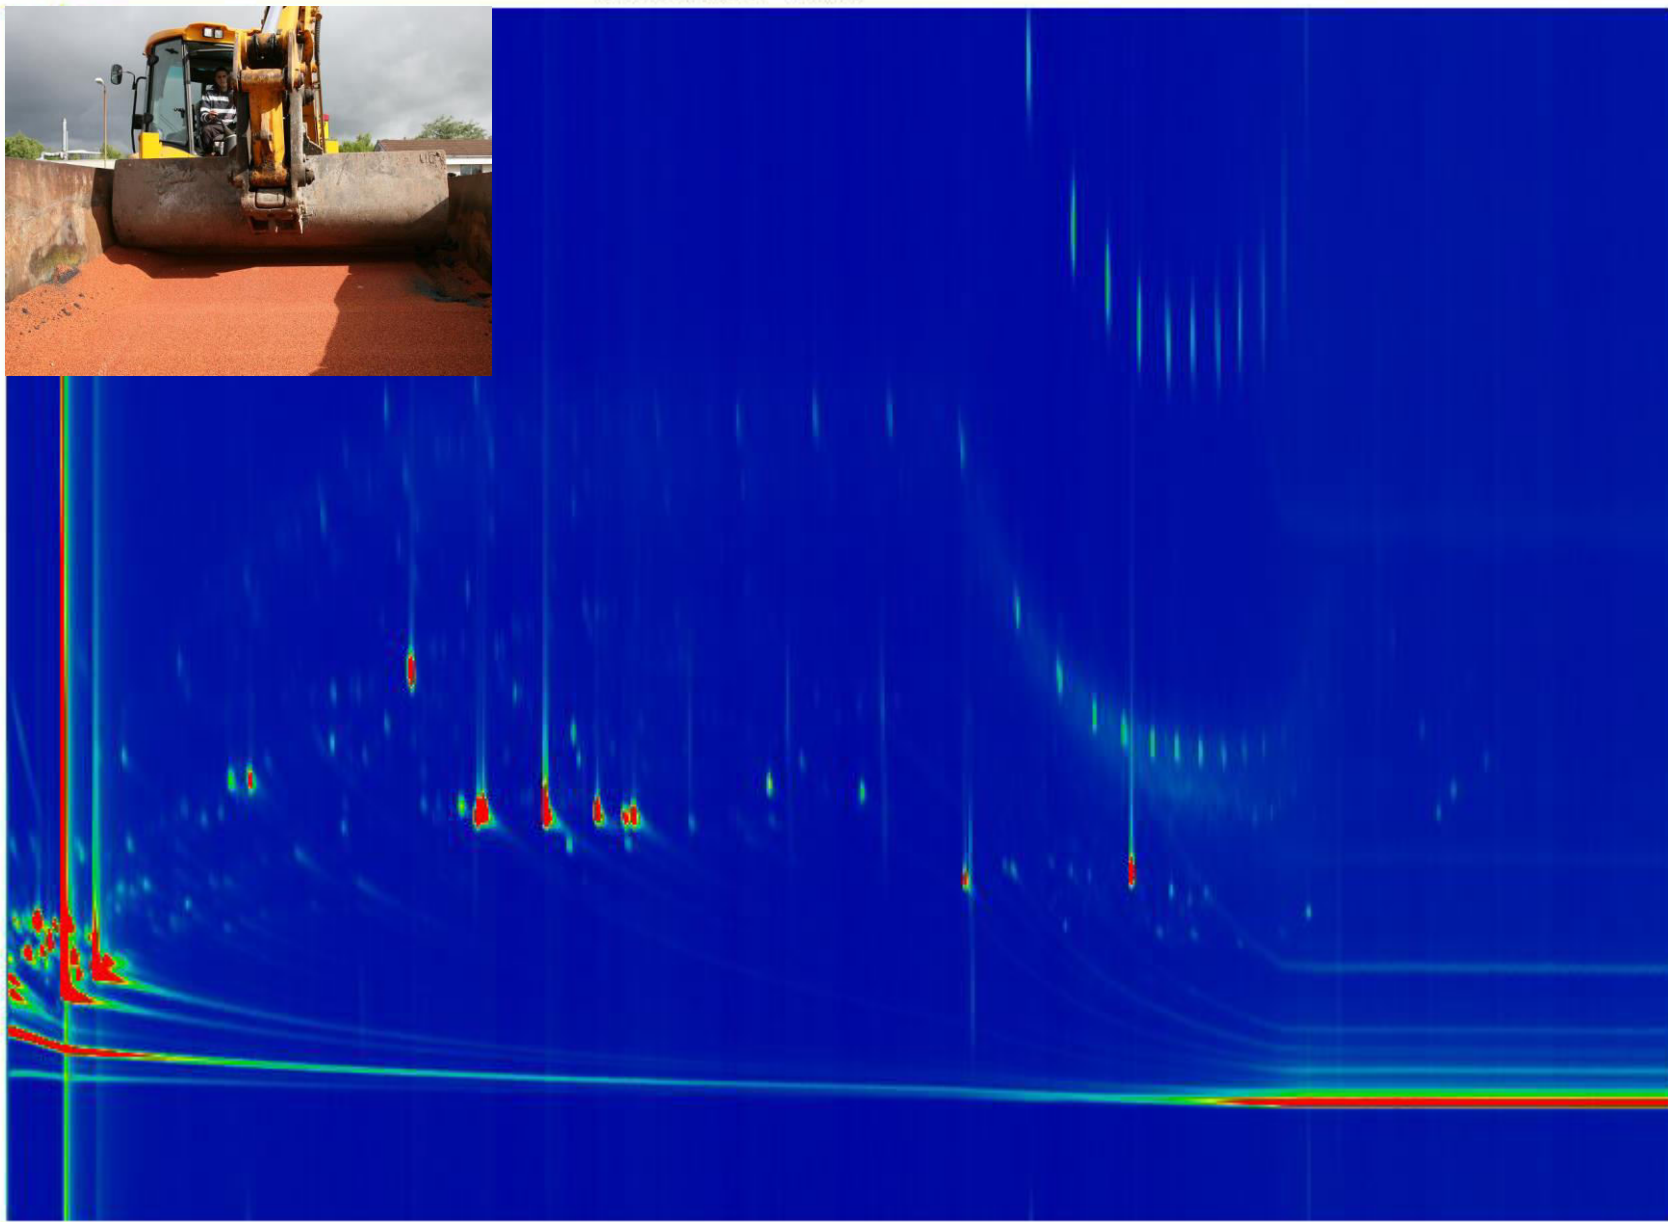
Fate of Organic Contaminants: GCxGC-TOFMS

Masses: TIC

After
remediation

2nd dimension (s)

1st dimension (min)

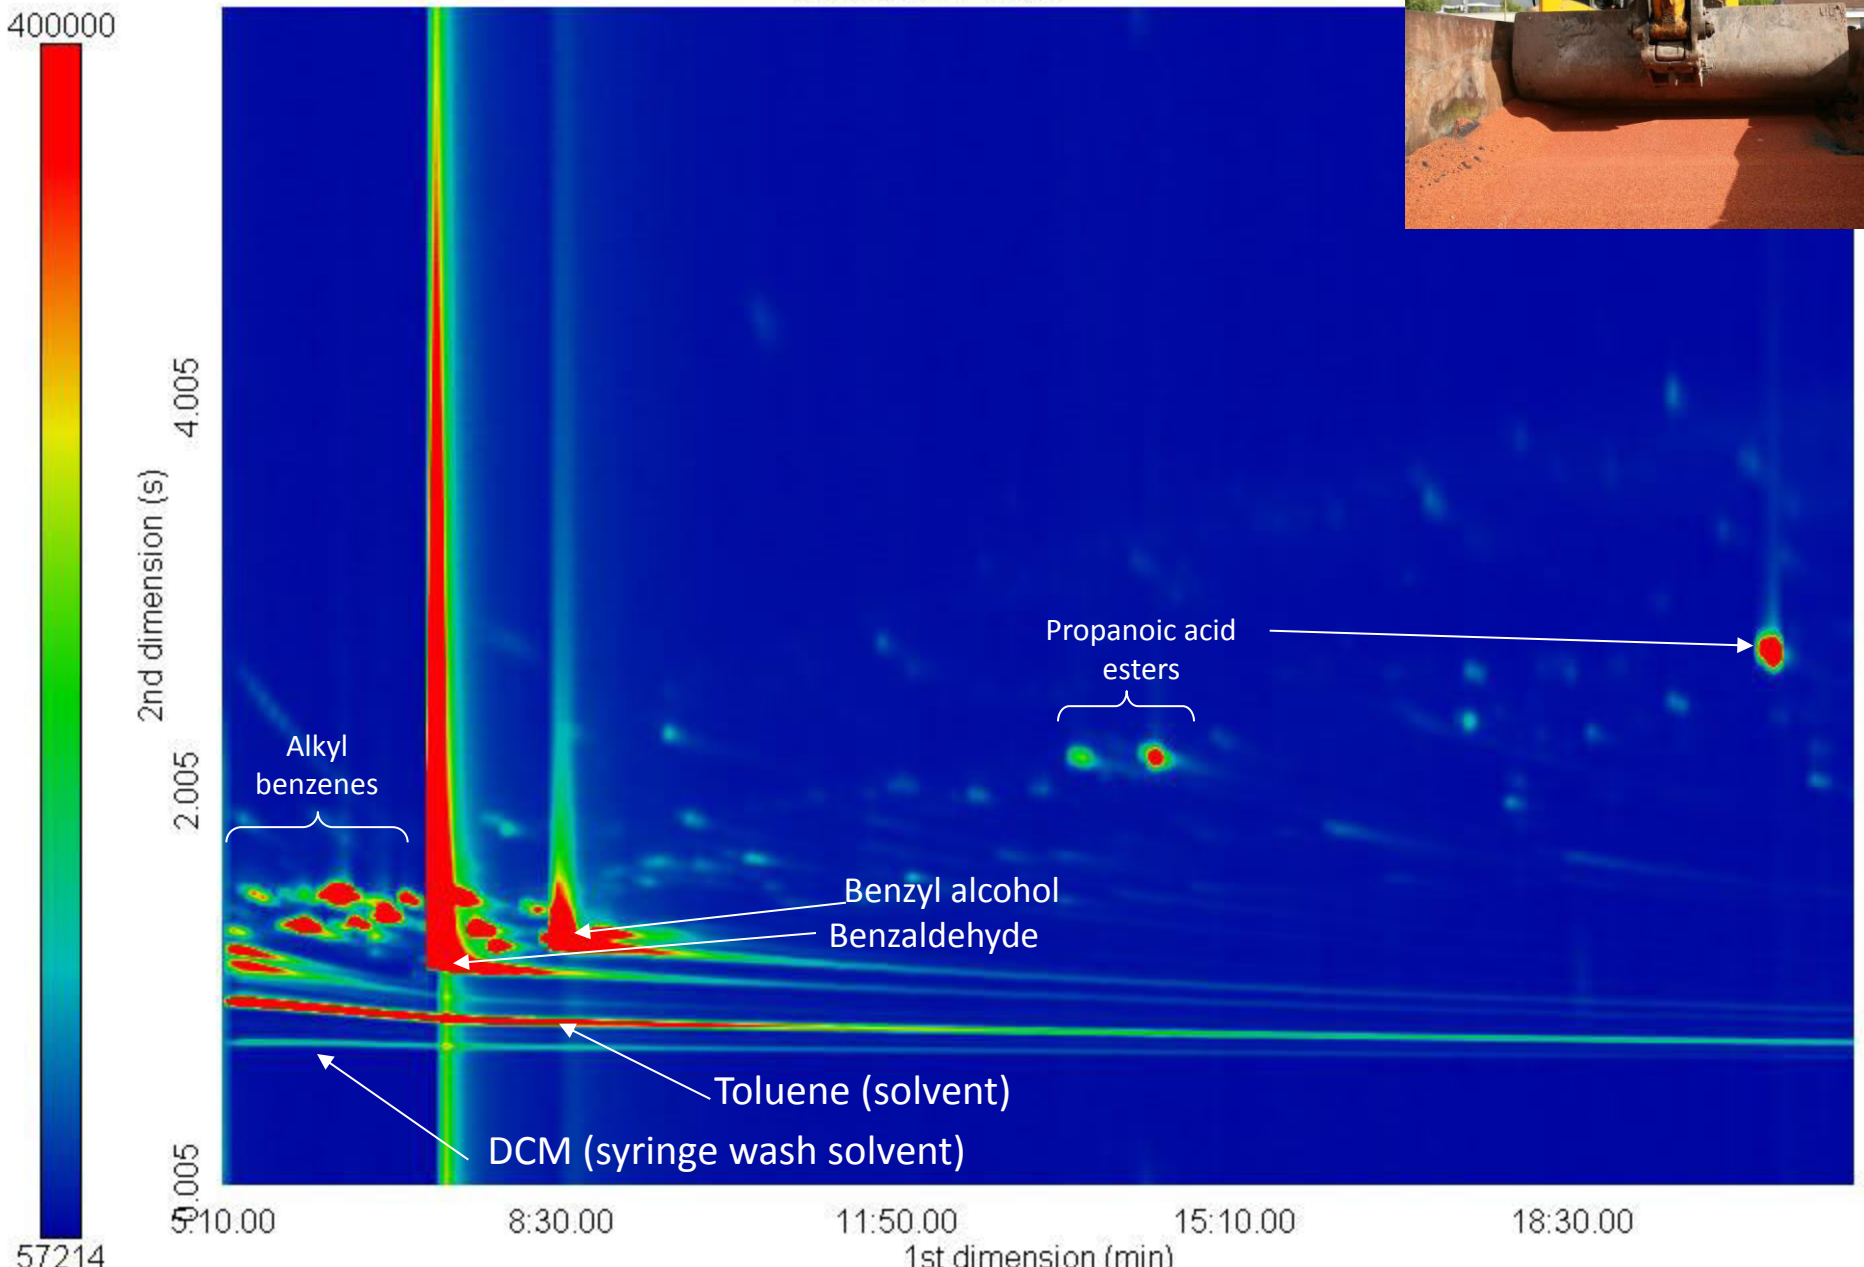
After remediation: front section zoomed

Masses: TIC

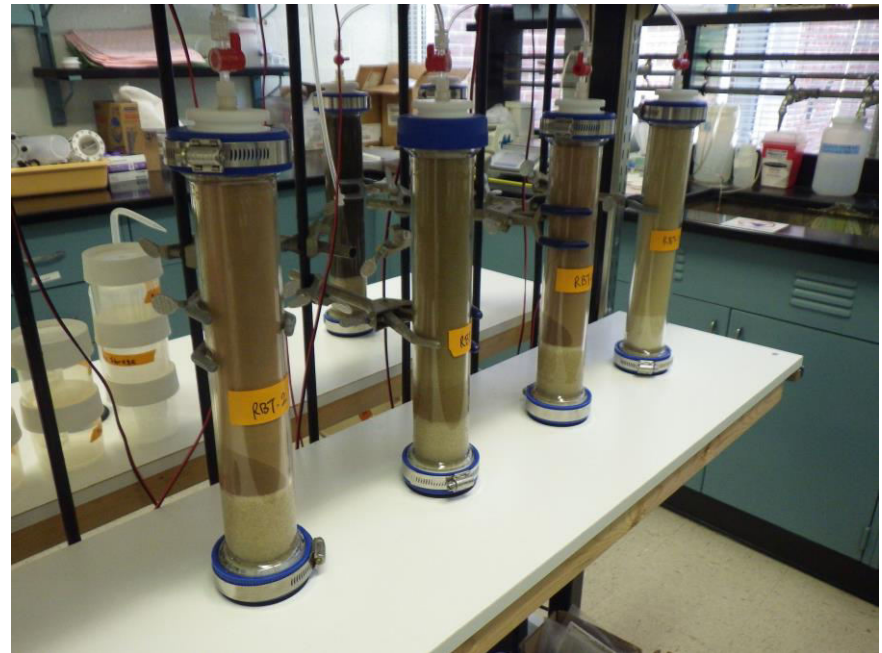
Potentially Toxic Element Availability

- USEPA M1313: pH dependent leaching
- USEPA M1314: column leaching (L/S ratio \uparrow)
- 2 soils: field-obtained loam and made ground

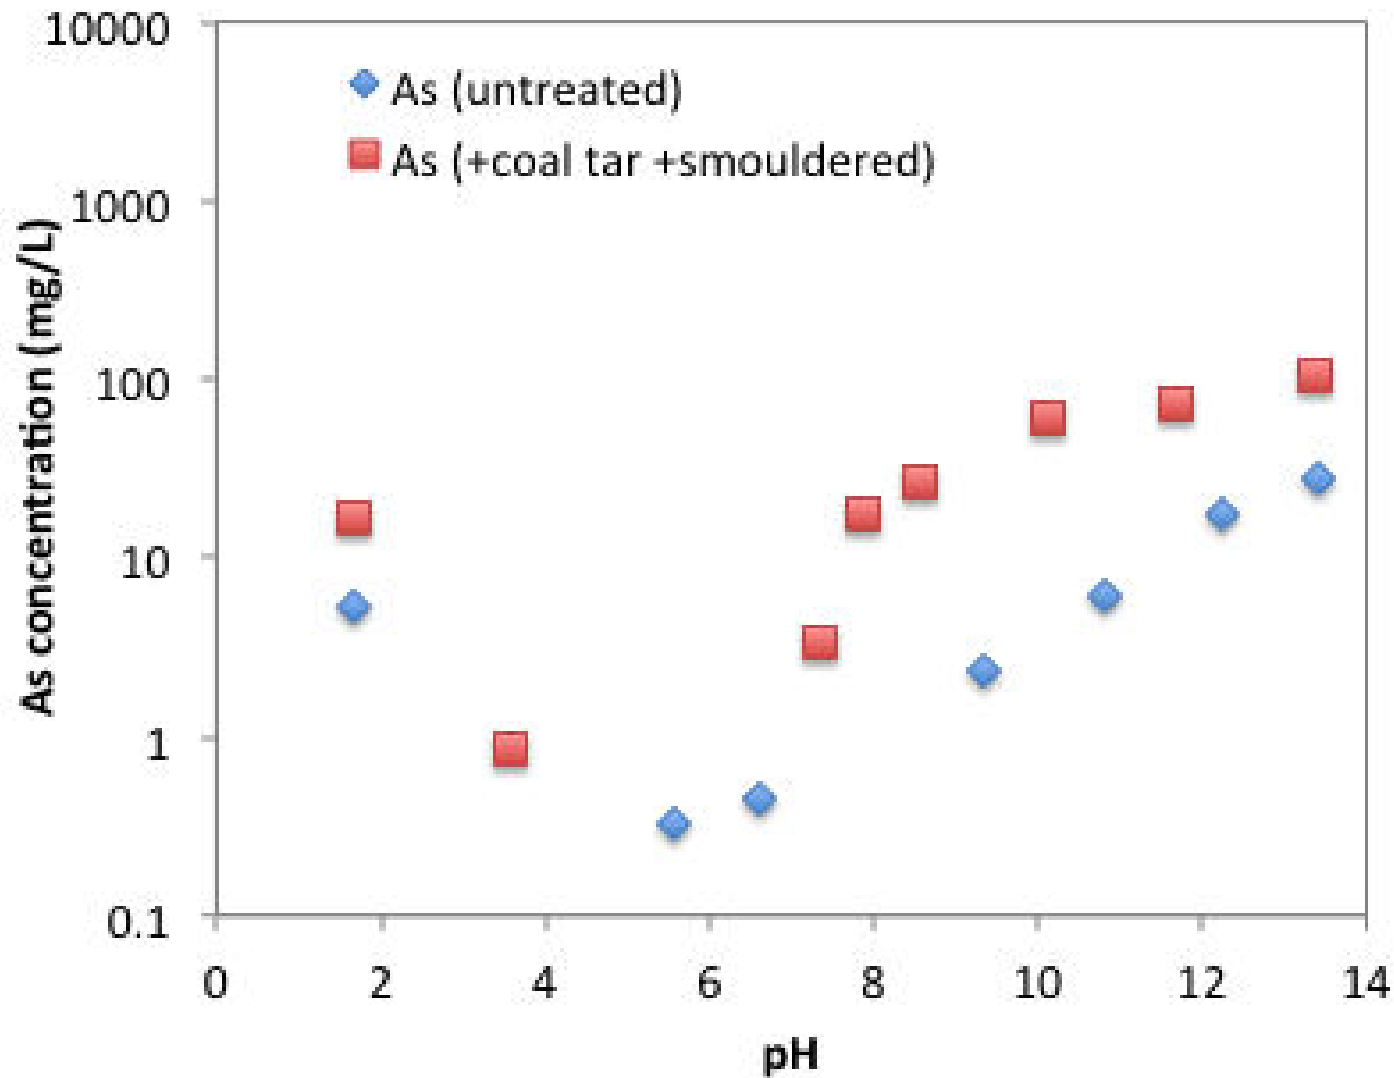
M1313 Results: Arsenic

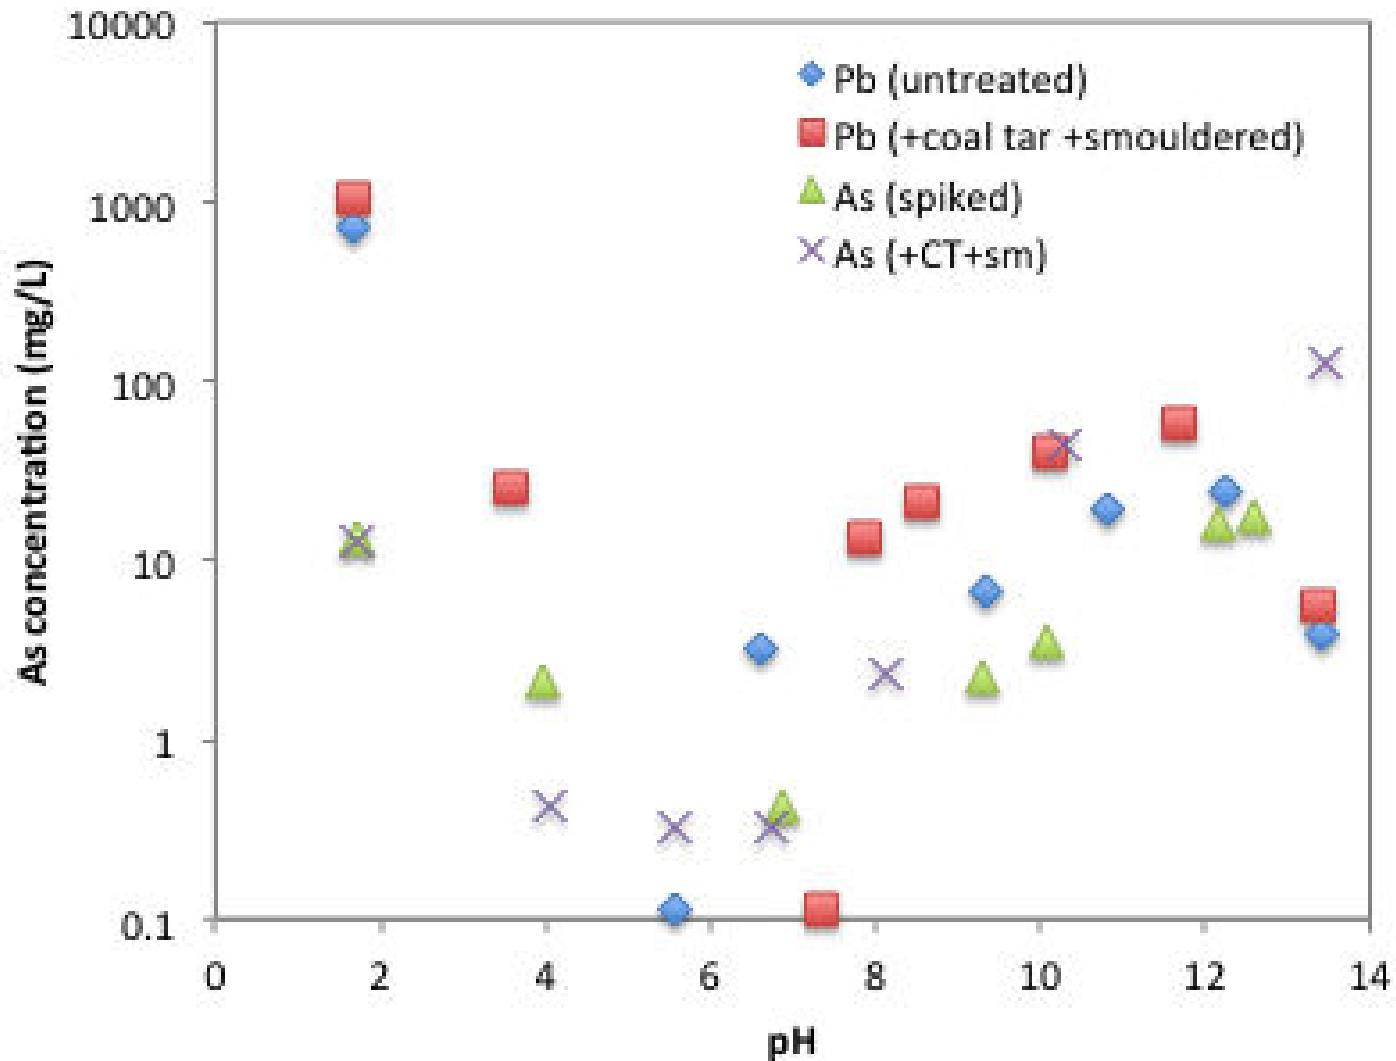
M1313 Results: Lead

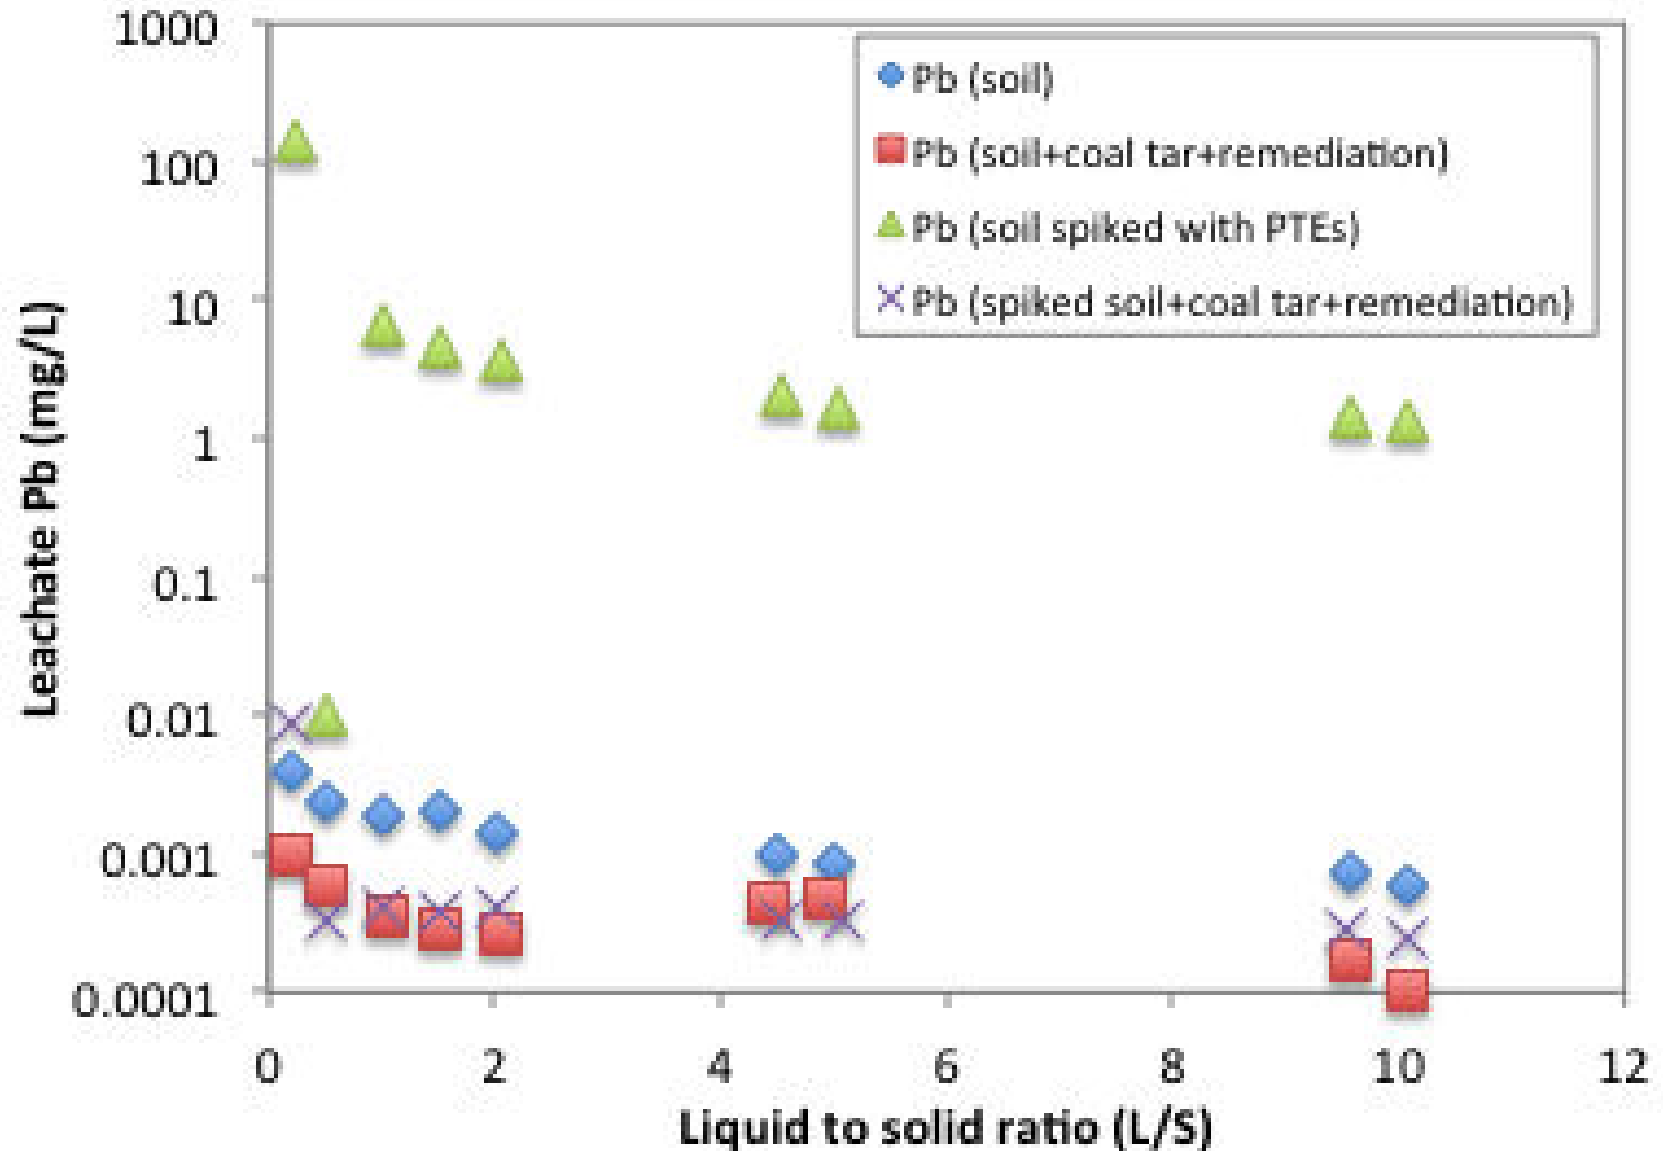
M1314 Results: Lead

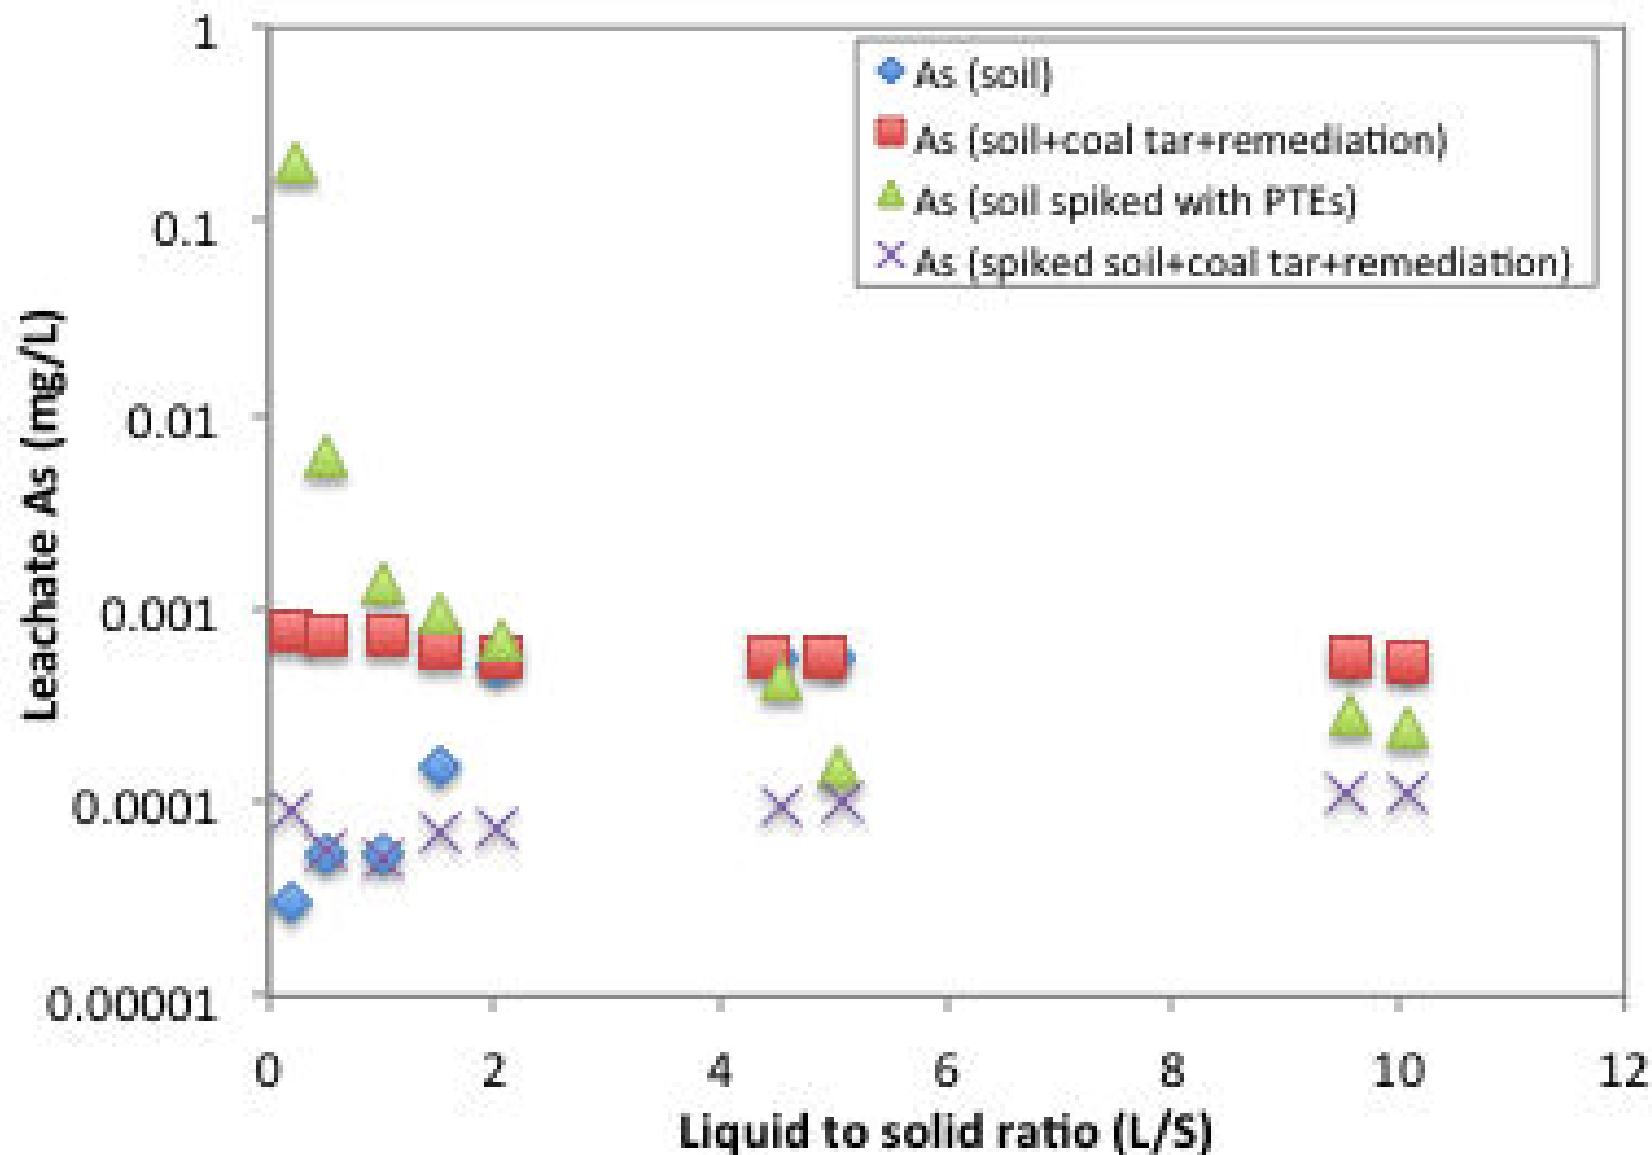
M1314 Results: Arsenic
