# Rainwater harvesting using check dams in gully of Ili Valley, China

Wentai Zhang 张文太  
Xinjiang Agricultural University

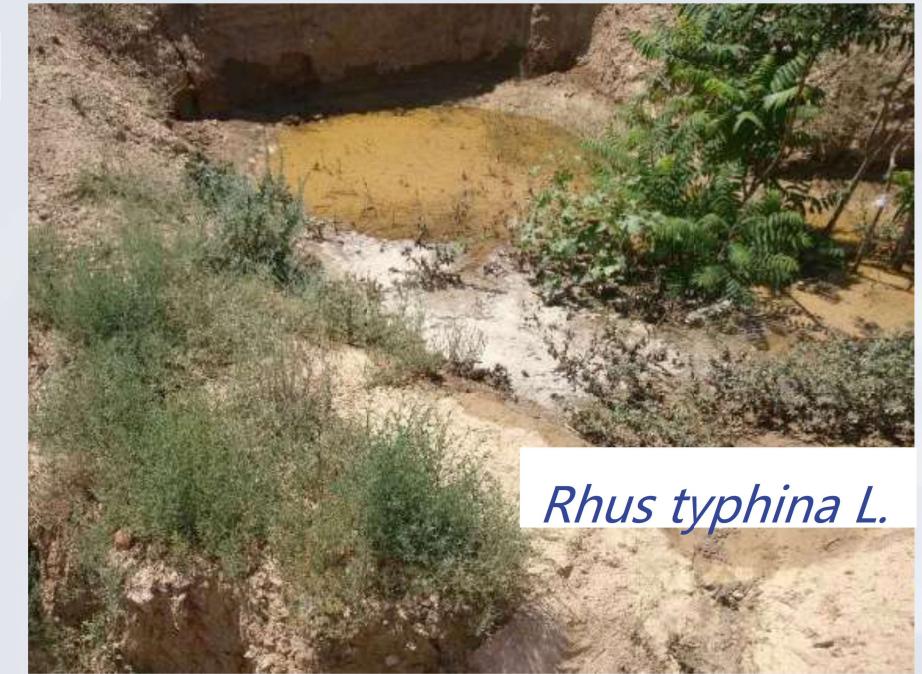
# Impact of check dam on storing water

Gully as the water flow channel became the ideal site for storing harvested rainwater

Check dams and the harvested rainwater sustained about 80 m<sup>2</sup> vegetation patches in the gully
