AN INTEGRATED APPROACH FOR DEBRIS-FLOW RISK MITIGATION IN THE NORTH COASTAL RANGE OF VENEZUELA

Jose L. Lopez and Francois Courtel

Institute of Fluids Mechanics, Universidad Central de Venezuela, C.P. 4725, Caracas 1041-A, Venezuela; Tel. +58 212 605 3131/3041; Fax. +58 212 605 3040.
jlopez@imf.ing.ucv.ve; fcourtel@imf.ing.ucv.ve;

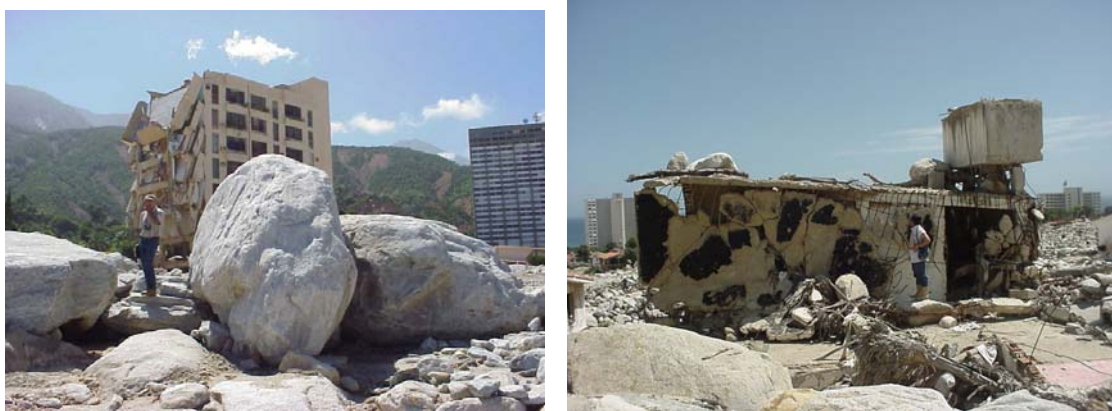
Figure 3. Damages by debris flows to two buildings on the alluvial fan of San Julian River.

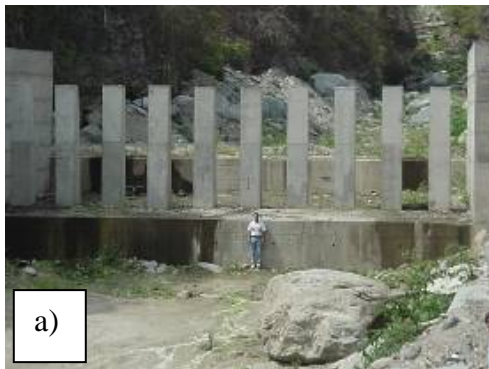
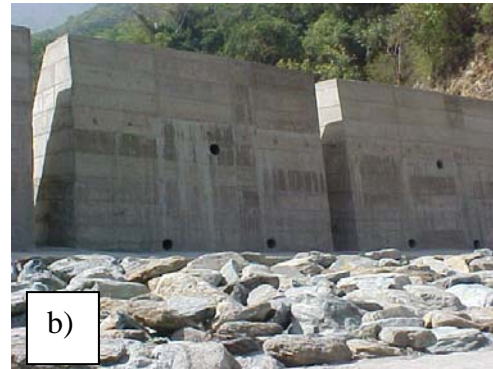
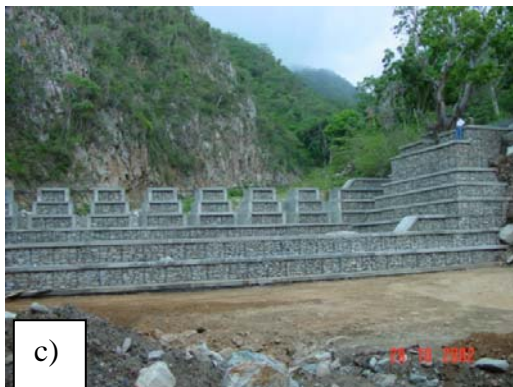
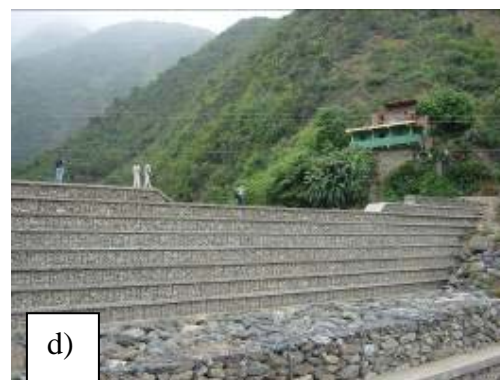
Figure 5. Different types of sediment control dams in the State of Vargas: a) a 4 m high reinforced-concrete slit dam in Quebrada Guanape; b) a 4 m high cyclopean-concrete slit dam in Quebrada Curucuti; c) a 3 m high gabion slit dam in Quebrada El Cojo; and d) a 7 m high gabion closed dam in Quebrada San Jose de Galipan.

In spite of floods and inundations of sediment that had occurred in the past in the north coastal range of Venezuela, only a very few (2) dams for sediment control purposes were present in the Avila Mountain, previous to 1999. One was completely destroyed by the debris flows and the other was severely damaged. After the 1999 event, government authorities initiated an intensive program to canalize the water courses in the alluvial fans and to build sediment control dams in the canyons of the main streams. Control works were designed for protection against a 100 year flood event. By December 2007 thirty five (35) sediment retention dams had been built in the torrents of Vargas. Table 1 shows the main characteristics of the dams built in the Avila Mountain. Basically, 23 of the structures are of the closed-type dam and 7 are of the open-type. Five of the dams were made in concrete, two in steel and all the others (33) in gabion. The maximum height of the dams is 11 m, and the minimum is 3 m. Figure 5 illustrates different types of retention dams that have been constructed in the State of Vargas.

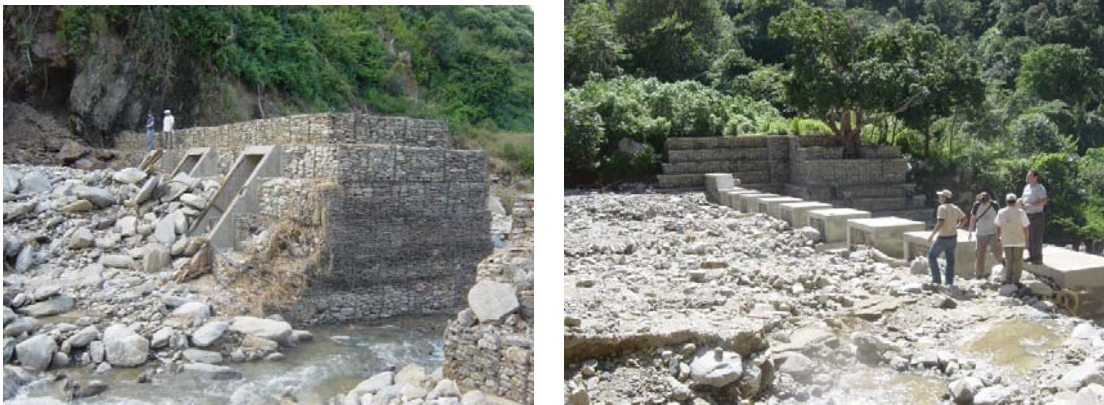
Figure 6. View from upstream of Camurí Chico window dam (left) and El Cojo dam (right).

In February 7-10th, 2005, an extraordinary precipitation occurred in the same region as the 1999 flood. About 400 mm were recorded in several stations during the 4-day storm. The predominant morphological process in this storm seems to have been the remobilization of sediment deposits left by the 1999 flows in the upstream reaches of the Avila Mountain. A large amount of sediment material and woody debris was transported downstream, and the damage to the urban areas was minimized due to the presence of the dams. Figure 6 shows the stage of two dams after the 2005 flood. The Camuri Chico dam is a gabion type open dam, six meters high, built in 2004, whose construction had not been completed by the time of the 2005 flood, lacking a central section provided of a gate for maintenance purposes. However the open dam acted adequately, retaining a large amount of cobbles and boulders that were accumulated in the lateral side channels, blocking partially some of the windows, and allowing a portion of the finer sediment load to be transported downstream. The El Cojo dam (Figure 5-c) is a slit gabion dam, 3 m high, built in 2002. The slit dam was almost filled up with coarse and fine sediment due to the obstruction of the slits by logs and boulders during the 2005 flood (Figure 6).

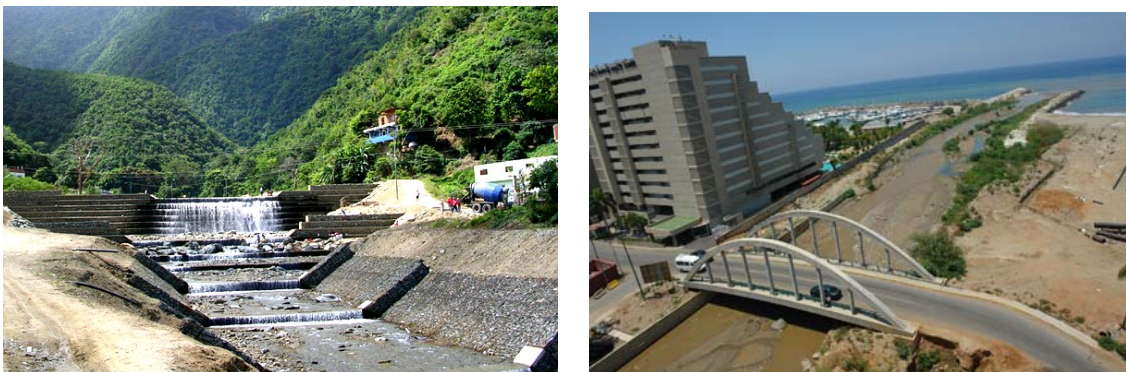
Figure 7. Canalization of San Jose de Galipan stream (left) and Tacagua stream (right) in the State of Vargas..

Canalization of some of the main streams has also been accomplished. Figure 7 shows a gabion channel built in the San Jose de Galipan stream and a concrete channel in the Tacagua stream.

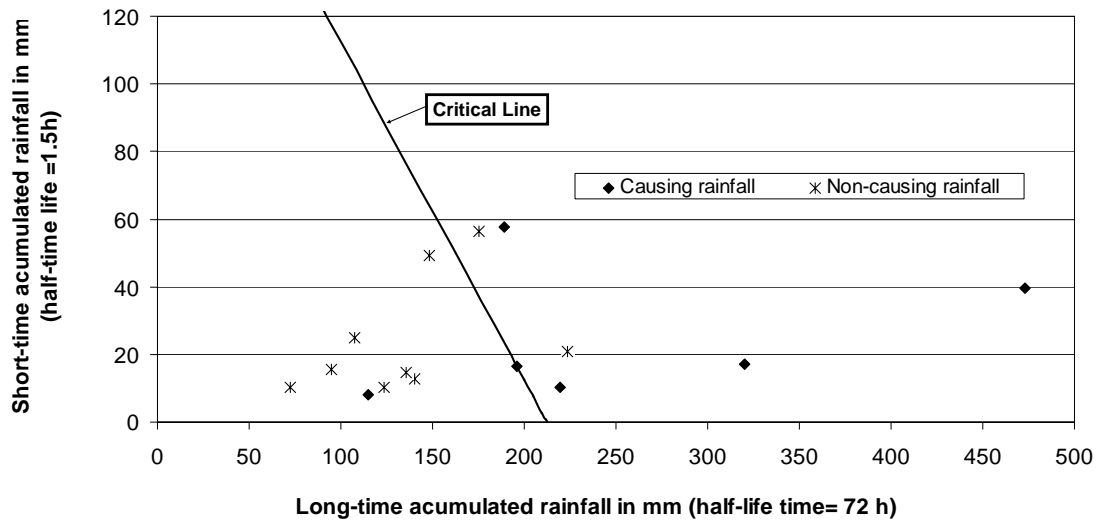
Figure 10. Critical line for debris flow initiation in the region of Catia La Mar.

The other component of the Data Interpretation System compares two rainfall indicators with predetermined critical values (thresholds) in order to identify the possibility of debris-flow occurrence. Specifically it checks the position of a representative point in an “Evaluation Graphic” built with these indicators as coordinates, where a critical line separates a safe zone from a risky zone. In case that the point approaches or passes this line, a special alert is emitted by the Technical Room.

Methodologies attempting to establish a relation between debris flows and previous rainfall are commonly used in several parts of the world to forecast such kind of phenomenon. There is a virtual consensus that one indicator have to be representative of the short-term rainfall (recent hours) and the other of the long-term rainfall (recent days), but they are different ways to choose the periods of the computation and the form of the indicators. The indicators used for the Early Warning System in Catia La Mar are weighted sums of past rainfalls, where the weight decreases exponentially with time, so that the influence of a specific rainfall on the indicator decreases with its oldness. It is similar to the “Committee Method” used in Japan, a country with a large experience in this field (IDI, 2004). The “half-life time” of the short-time indicator (that is the time for which the weight is 0.5) is 1.5 hour, and 72 hours for the long-time indicator. It means in short that rainfall of more than 10 hours and 20 days oldness has virtually no more influence on short-time and long-time indicators, respectively. To determinate the critical line in the Evaluation Graphic, a historic investigation was necessary as to represent both debris-flow events occurred in the past (causing rainfalls) and extreme past rainfalls that didn’t cause debris flows (non-causing rainfalls). The difficulty rose from the few number of documented debris-flow events and the lack of rainfall records, especially hourly ones. To overcome this last inconvenient, a relation between hourly and daily maximum rainfall was established from stations with complete records. Finally a critical line was drawn, managing to separate the two groups of events, even though some points inevitably remain in the “wrong” zone. The graphic currently in use in the Catia La Mar EWS is shown in Figure 10. It must be considered as a first attempt that will be improved in the future with the further monitoring of the watersheds.
