# Dam Safety and Risk Management in Taiwan

Sinotech Engineering Consultants

### Case Study: Xinshan Dam

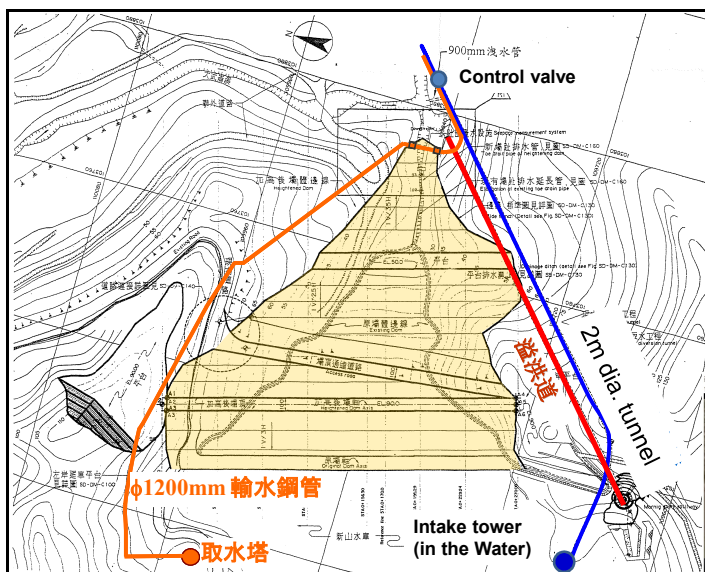
## Water Intake System (Phase I)

- What we know**
  - The location of the intake tower.
  - The location of the control valve downstream.
  - A 0.9-meter diameter steel pipe is connected to a 2-meter diameter tunnel through a transition part in front of the control valve.
  - Max water head in the pipe may be up to 50 m.
- What we don't know**
  - The details of the entire system.

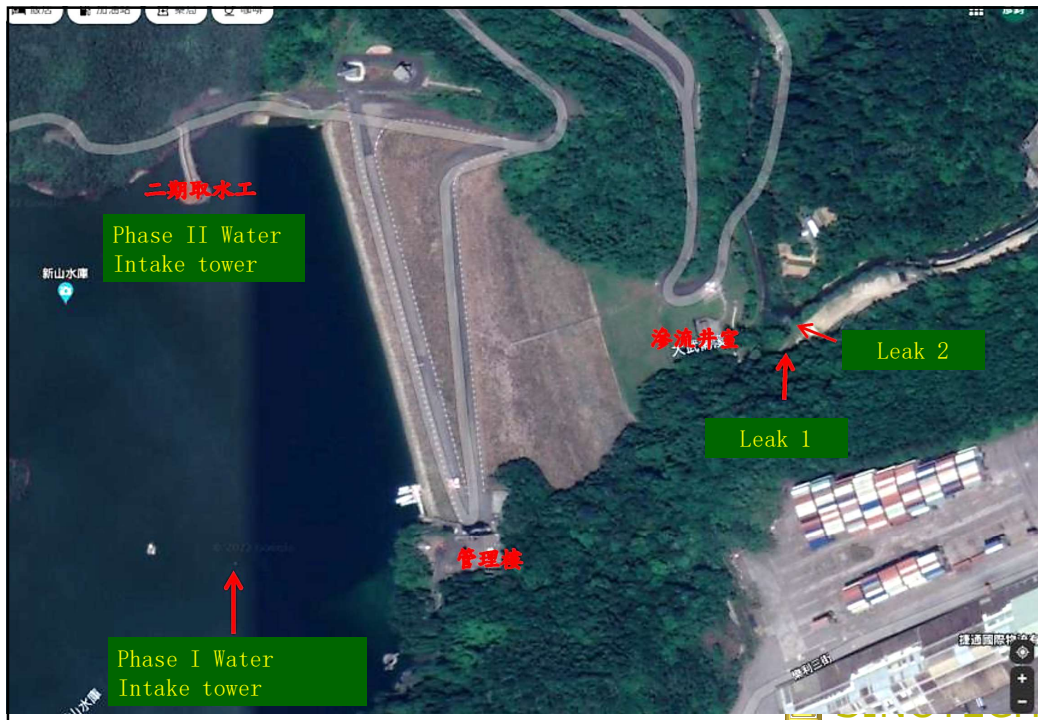
- 🌐 In June 2022, two leaks were observed at the weak points of Phase 1 intake tunnels/pipes.
- 🌐 Based on the results of the PFMA, these leaks may indicate that pipe failure is occurring, which could eventually lead to uncontrolled but limited reservoir discharge. However, they do not pose a risk of dam failure.
- 🌐 Subsequently, an investigation was conducted to identify the source of these leaks.

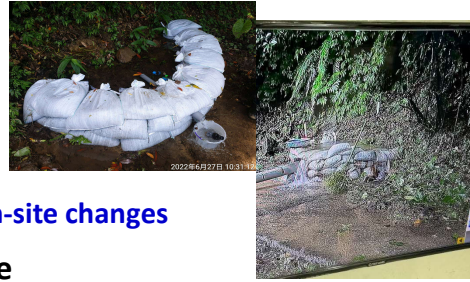
- ➔ Observing seepage quantity
- ➔ Installing cameras to monitor on-site changes
