The importance of Water Quality inside Peru by accredited laboratories in

ISO/IEC 17025

Eng. Jorge Oswaldo Echevarría Velásquez

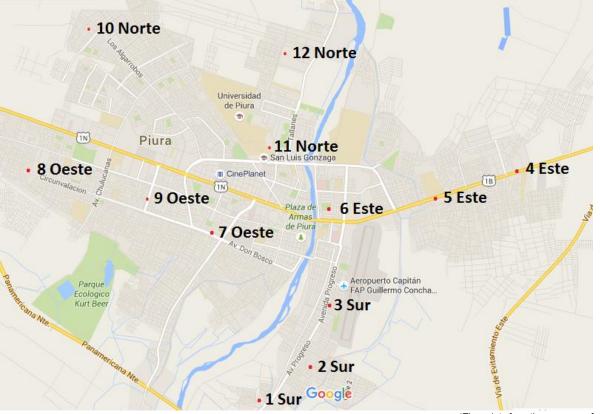
Also, it has been marked in a referential way in a map from the city of Piura the location of each one of the twelve sampled points in this study to visualize the distribution of the selected points for this research paper. Next, the map with the sampled points is shown.

*The points from the map are referential

The methodology used for this water quality study has been performed by taking samples at different points in all the City of Piura (District of Castilla, Castilla and 26 de octubre), distributed in four areas of the city: the first area was the South area with three sampling points, which were called point "1 South", point "2 South" and point "3 South". The second area was the East of the city with three sampling points: "4 East", "5 East" and "6 East". The third area was the West with three sampling points: "7 West", "8 West" and "9 West". Finally, we sampled the North area with three points: "10 North", "11 North" and "12 North".

All twelve sampled points in this study were distributed throughout the city of Piura. In the top table, the code of the point, the reference of the capturing of the simple, the exact coordinates where the sample was taken as well as the altitude of the sampled point are shown.
