INFILTRATION ASSESSMENT FOR BETTER WATERSHED MANAGEMENT IN NORTHERN MEXICO Evaluation de l'infiltration pour une meilleure gestion de basin au Nord Mexique

José Luís González Barrios¹, Jean Pierre Vandervaere², Ignacio Sánchez Cohen¹, Guillermo González Cervantes¹, Luc Descroix²

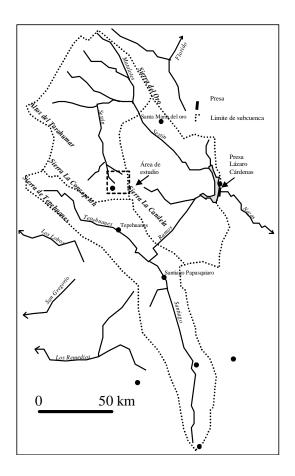
Figure 1. The upper watershed of the Nazas River

The upper watershed of Nazas River has an area of 18 321 km2 in a mountain zone within 1600 and 3200m altitude (figure 1). It has a semiarid to sub-humid climate with a year rainfall from 500 to 900mm.

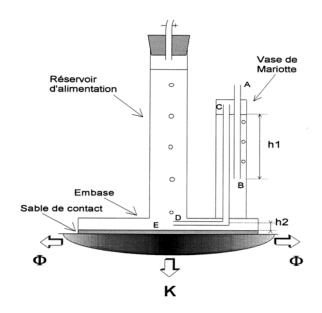
Figure 2. Disc infiltrometer

Triple Ring Infiltration Method (Vandervaere, 1995; figure 2) was useful for measuring infiltration rates with three discs of different radius (4, 9 and 12 cm) under constant water charge conditions, and four suction forces imposed to soil (-100, -60, -30

and -10mm). Other complementary parameters such as: soil texture, soil water content and bulk density, were observed as well.

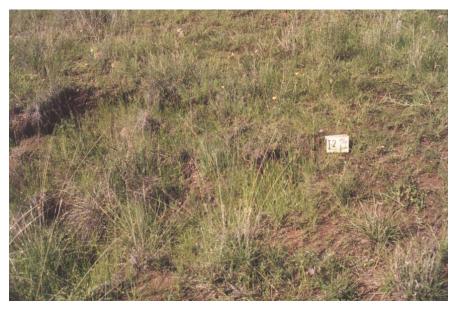
Figure 3. Grassland surface

Three representative sites of soil surface in the upper watershed of Nazas River were chosen for infiltration assessment. They can be related with the main natural and disturbed area features (Descroix *et al.*, 2007): Grassland surface with *Bouteloa gracilis* (figure 3); Forest surface with pine-oak humus (figure 4); and almost bare and compact surface related with disturbed areas of high intensity activities for forestry and cattle breeding (figure 5).

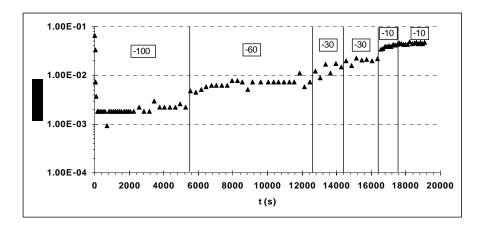
Suction force	-100	-60	-30	-10
applied (mm)				
Final infiltration rate (mm/h)	8.13	27.36	73.44	166.68

Figure 6. Infiltration on Grassland surface

Figures 6 to 8 show the infiltration rates on each soil surface. In all tests, infiltration flux decreases quickly at the beginning, then it fluctuates until a certain stabilized value; this stabilization could be related to a steady state. Suction force is then reduced and infiltration flux increases again until a new stabilized value. This operation is repeated for all different suctions in order to determine soil functional porosity. Infiltration flux generally increases when imposed suction forces diminish but, this is not happened on forest surface (figure 7) where infiltration flux did not increase when suction force has been changed from -100 to -60mm and -30mm. Forest surface showed a water repellency behavior until the 16000th second when infiltration flux increased suddenly, certainly because humus surface became wet. Late measurements with increasing suctions forces showed an irreversible effect (hysteresis) on infiltration rates.

Grassland surfaces show infiltration rates from 8 to 166 mm h-1 (from -100mm to -10mm suction force applied, respectively) reflecting a good structured porous media in soil (figure 6). Functional porosity into soil is ordered and quite connected since micro-porosity is well relayed by middle and macro-porosity along the infiltration test. Soil reacts as a high permeable body for hydrological transfers into deeper water cycle compartments.

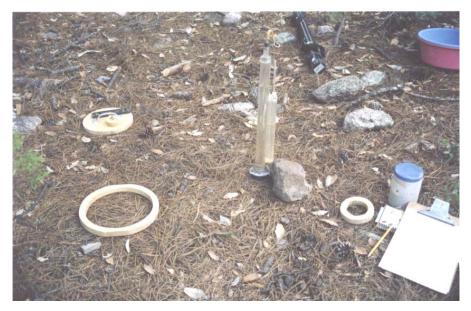
Figure 4. Forest surface

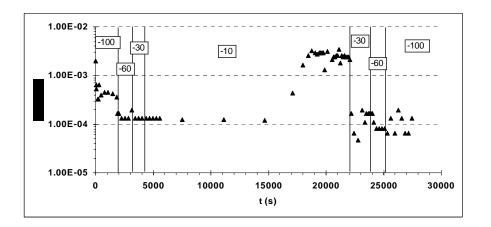
S.F.A. (mm)	-100	-60	-30	-10	-30	-60	-100
F.I.rate (mm/h)	1.71	0.5	0.47	9.10	0.57	0.31	0.35

Figure 7. Infiltration on Forest surface

Forest surfaces show infiltration rates from 0.5 to 9 mm h-1 (figure 7) with a repellent phenomenon at the beginning of the test, certainly linked to the abundance of pine-oak humus with many water repellent compounds from aromatic and aliphatic origin; moreover, dry initial conditions in soil humus increase repellency to water. Nevertheless, functional porosity into soil seems to be ordered as well as grassland surfaces. Soil reacts as a permeable body when humus is completely wet.

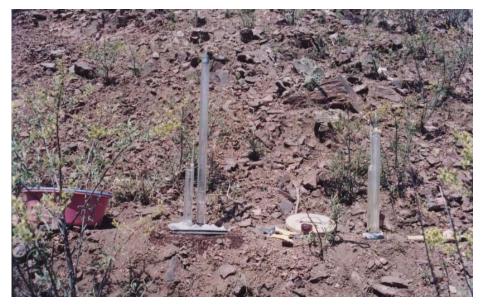
Figure 5. Disturbed surface

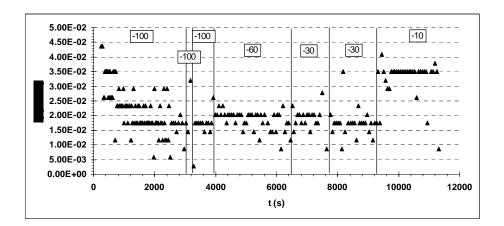
S.F. applied (mm)	-100	-60	-30	-10
Final Inf. rate (mm/h)	60.84	63	60.84	127.08

Figure 8. Infiltration on Disturbed surface

Disturbed soil surfaces show infiltration rates from 60 to 127 mm h-1 with almost no difference between infiltration fluxes under the suction forces applied (figure 8). This reflects not well structured porous media in soil. Infiltration fluxes and rates are disordered and do not show good connection in functional porosity along the suction forces applied. Soil reacts as a low permeable body for hydrological transfers.
